**WEIR RIVER BASIN
HINGHAM, MASSACHUSETTS**

**ACCORD POND DAM
MA 00430**

PHASE I INSPECTION REPORT NATIONAL DAM INSPECTION PROGRAM

APRIL 1979

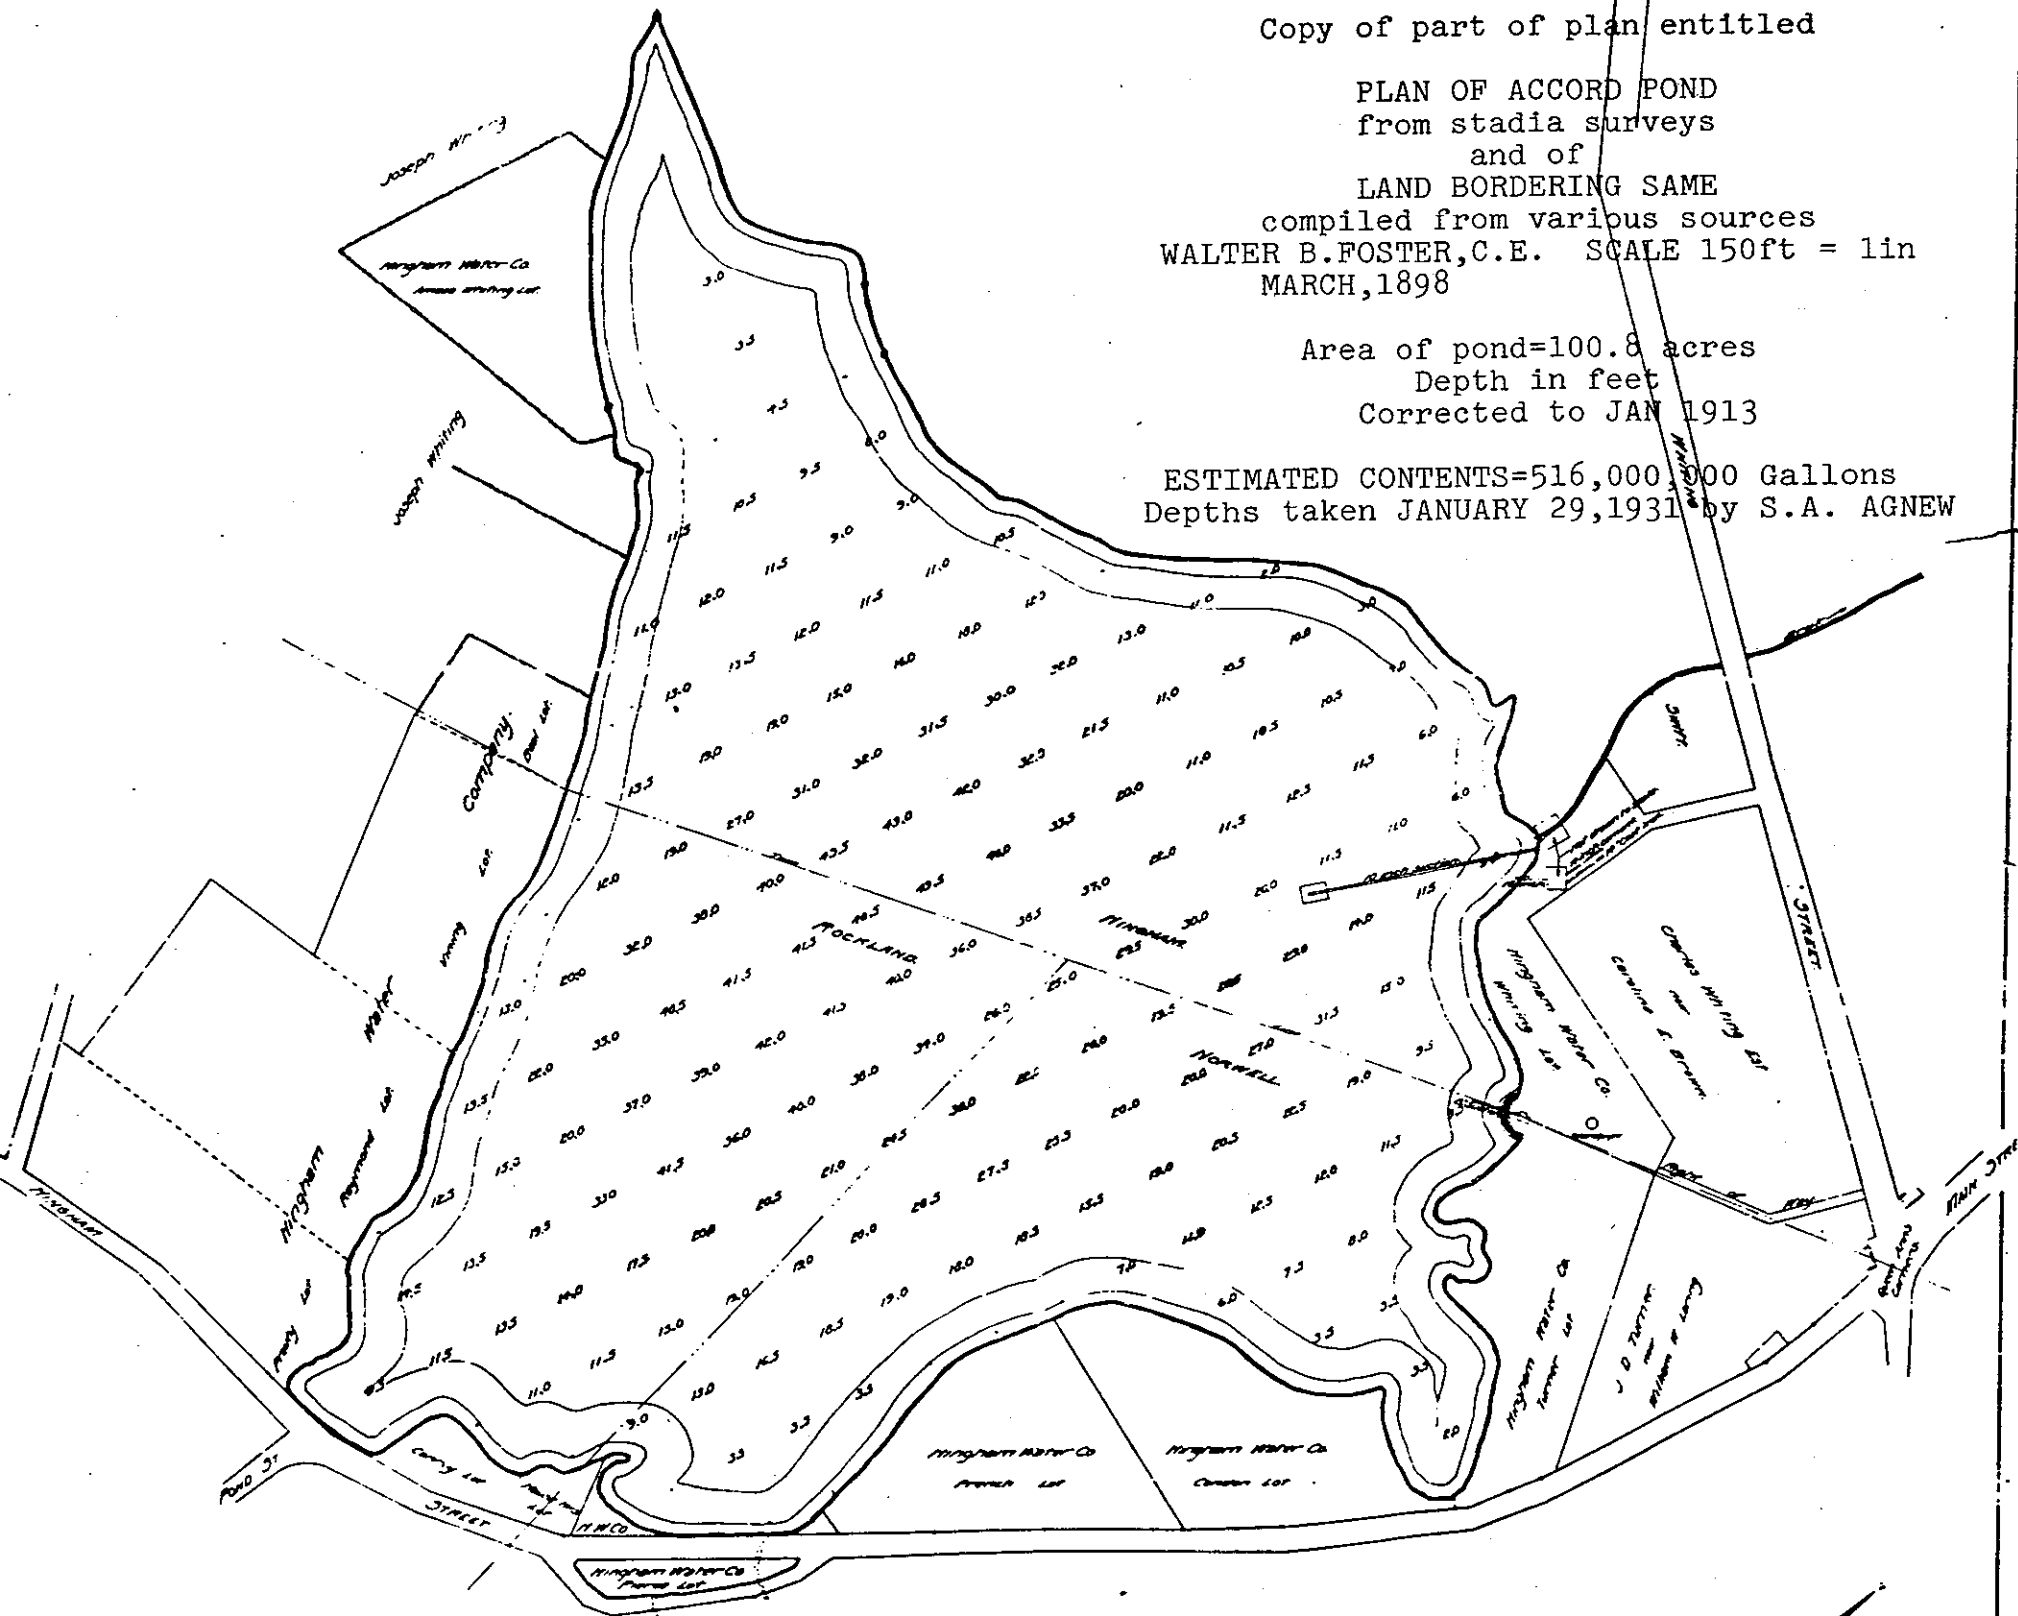
Copy of part of plan entitled
 PLAN OF ACCORD POND
 from stadia surveys
 and of
 LAND BORDERING SAME
 compiled from various sources
 WALTER B. FOSTER, C.E. SCALE 150 FT = 1 IN
 MARCH, 1898

- 2.1 General. There is only one plan related to Accord Pond Dam available from the Hingham Water Company. It shows water depths, property lines, and the locations of outlets at Accord Pond (copy included in Appendix B). The plan is dated March, 1898 with revisions in 1913 and 1931. No other plans, specifications or computations are available from the Owner, State or County offices relative to the design, construction or repair of this dam.
